# Geotechnical evaluation of gully erosion and landslides materials and their impact in Iguosa and its environs, southern Nigeria

**Background:** Detailed field surveys and geotechnical evaluation of soils in Iguosa and its environs, Southern Nigeria, were undertaken to determine the root causes, mechanisms, and impacts of landslides and gully erosion. This was done to suggest appropriate mitigation measures to reclaim the affected land and prevent future occurrences in the study area.

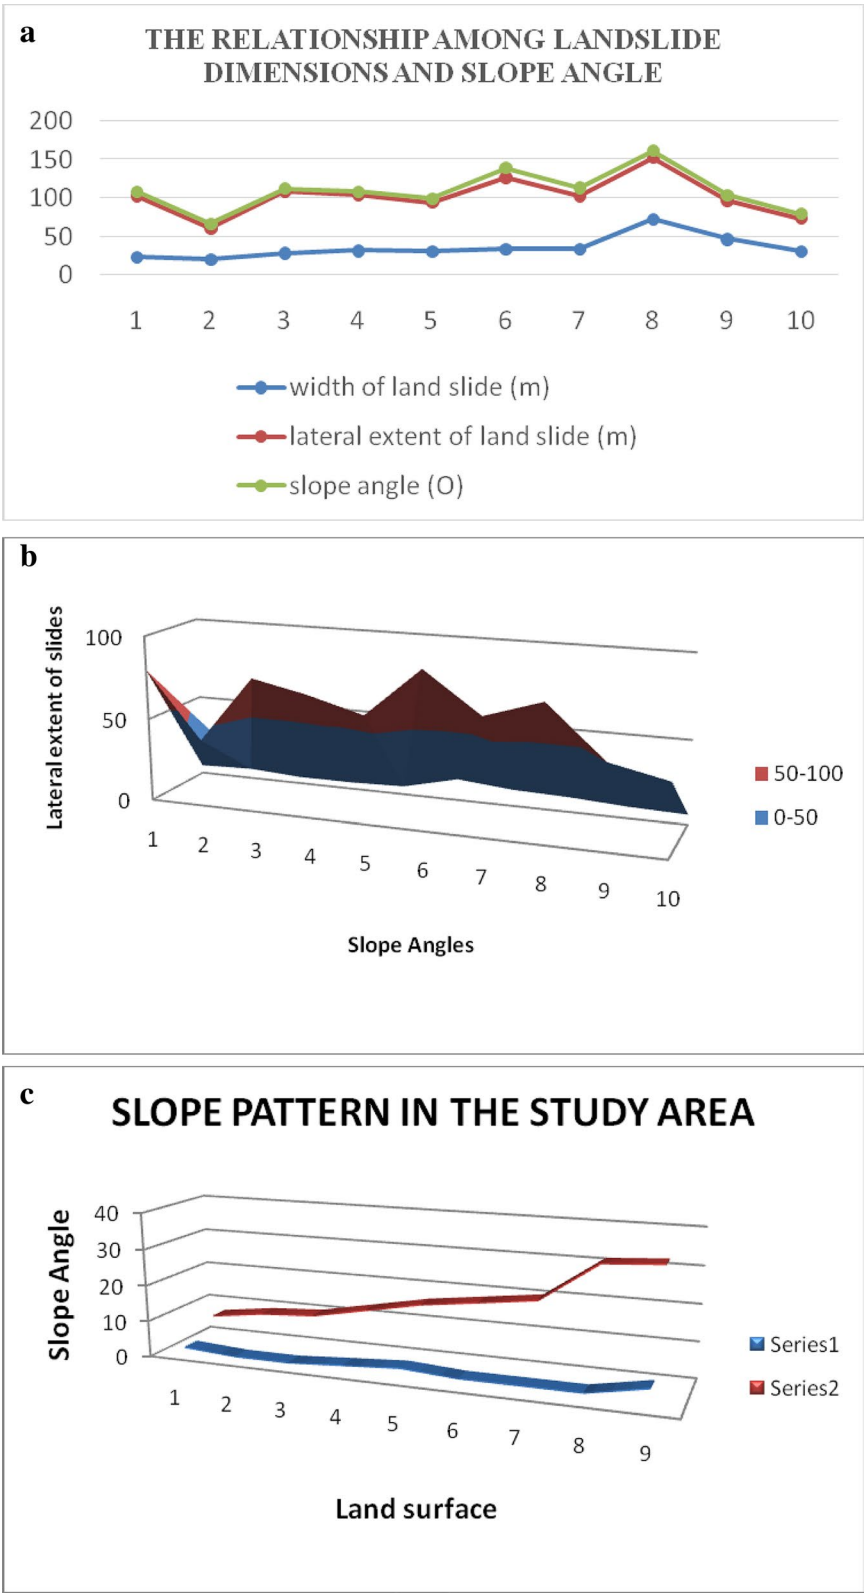
**Fig. 5** **a** Plot of dimensions of landslides (m) against slope angles of the landslide. **b** 3D surface view of lateral angles versus slope angles of the landslide in the study area. **c** Slope pattern of the sliding in the study area

the slope angles of the landslides (Fig. 5a). From Fig. 5b, the blue colour shows the initial stage of the sliding as a very gentle to gentle slope. The red colour shows the advanced stage of sliding from a moderately steep slope to a steep slope in the study area. As the width of landslides increases, the lateral extent of the landslides relatively increases, and these occur more on the slope angles of 22.5° and elevations of 183.11 m. From the plot of the dimensions of the landslide against the slope angles of

the landslides (Fig. 5a). The elevation, width, and depth values of the landslides and gullies indicate that the sliding is almost at the same rate. These sliding activities are prominently trending in the northeast direction of the study area (Fig. 5b, c). The lithological study revealed that the topmost layer of the gully profile consists of dense lateritic soil, underlain by Ajali sands and then some clay materials at the slide walls and floor of the slides/gullies. The Ajali sand is primarily medium to coarse-grained, friable, and unconsolidated sands of 250 cm thickness in the landslides area. Also, within the landslide areas, the units are inter-bedded by clay and silty soils. The photographs of some of the landslides and gullies in the study area are displayed (Fig. 6a–e).

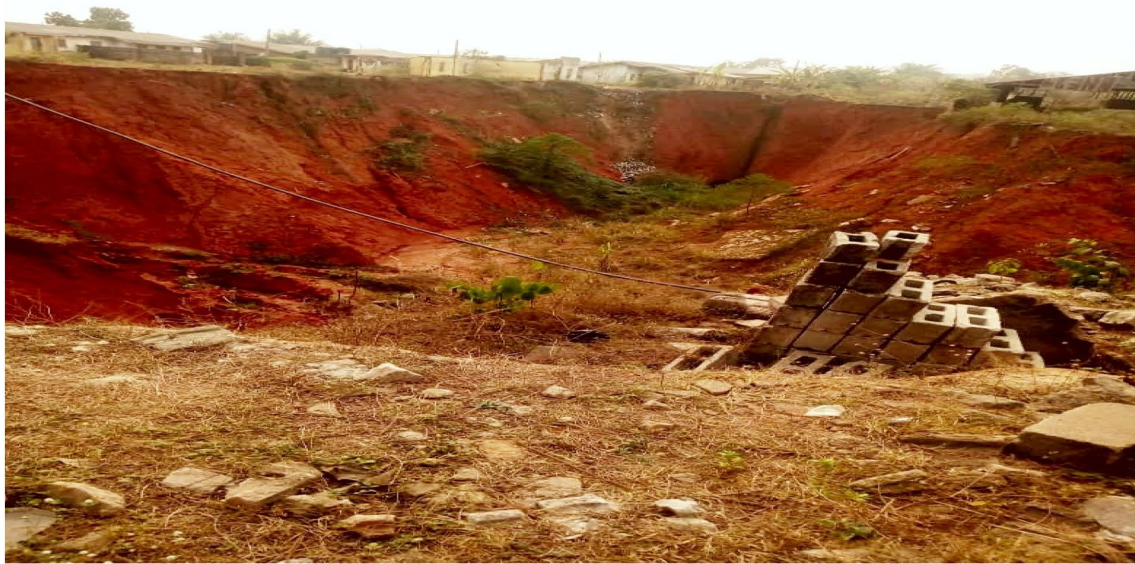
**Fig. 9** **a** Landslide on Iguosa area threatening lives and properties in the study area. **b** The road leading to various homes in the study area have be truncated by erosional activities (photo by Aigbadon)

the study area (Fig. 9a). The road leading to various homes and farmlands has been negatively affected by landslides and gully erosions in the study area (Fig. 9b).

Following those key findings, improving the drainage control and slope flattening will reduce the weight of the mass tending to slide and increase the resistance to sliding and hence increases the stability as recommended by (Egboka et al. 2019). The landslide areas should be

covered with impermeable layers/materials and diverting the surface water away from the landslide areas. Gray and Sotir (1996) employed biotechnical slope stability method for slope failures and gully erosion problems. Such method should also be deployed in the study area to
